Cased Pipeline Assessment

What We've Seen & What Worked

Alabama Public Service Commission Gas Pipeline Safety

32nd Annual Seminar

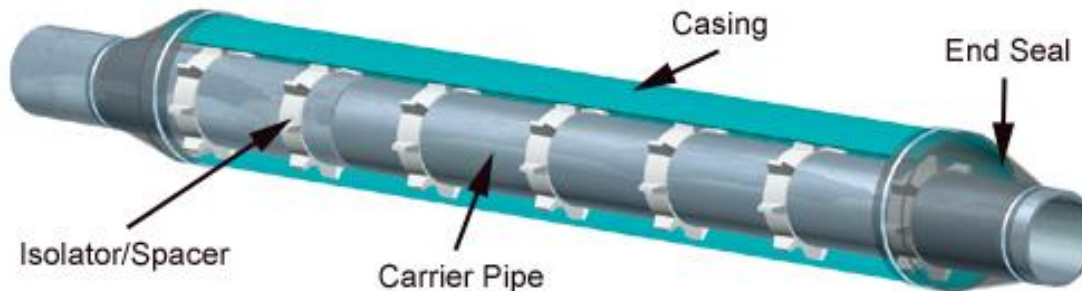
Steel Pipelines cased for mechanical protection

- **Electrochemically Isolated Space**
- **Difficult Access**
- **Difficult to protect from Corrosion & Prove it**

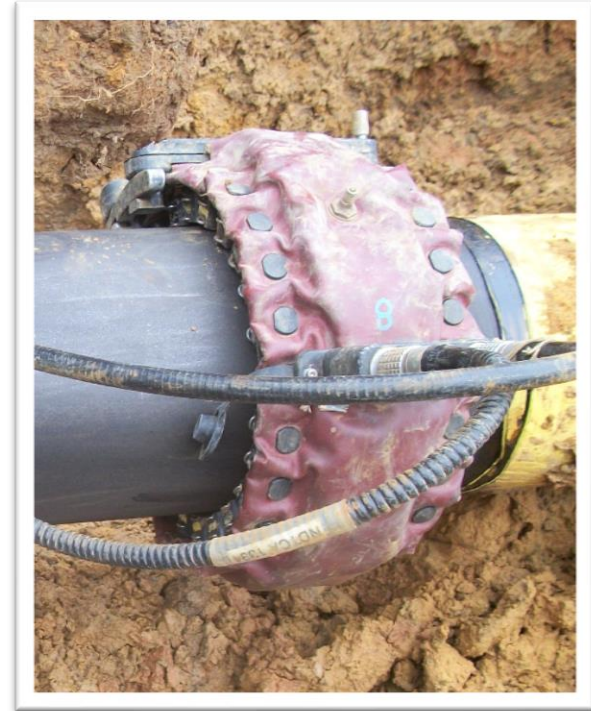
• Testing ~20 Casings & Direct Examinations

- Old Pipeline, new to Operator
- Line was shut down for testing
- Tested all casings, ECDA
- II Tools: GWUT, Internal Resistance

- No shorts
- GWUT found coating damage accurately
- 100% DA for pulled segments

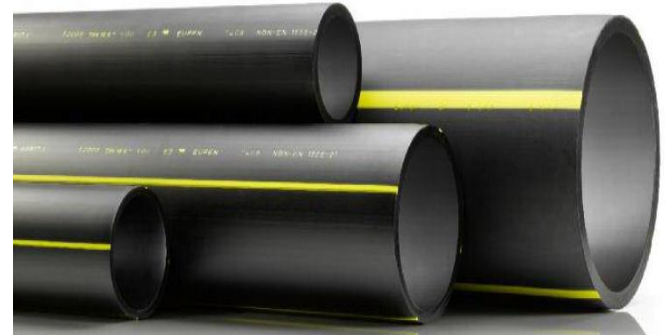
• Steel Line in Plastic Casing

- 6" Distribution Pipeline
- Casing ends not sealed
- Line was active – could not immediately shut down

- Recommended excavation of both ends
- Wash casing & inspect for clean annulus
- Install corrosion coupon, zinc electrode, pipe test leads
- Seal ends

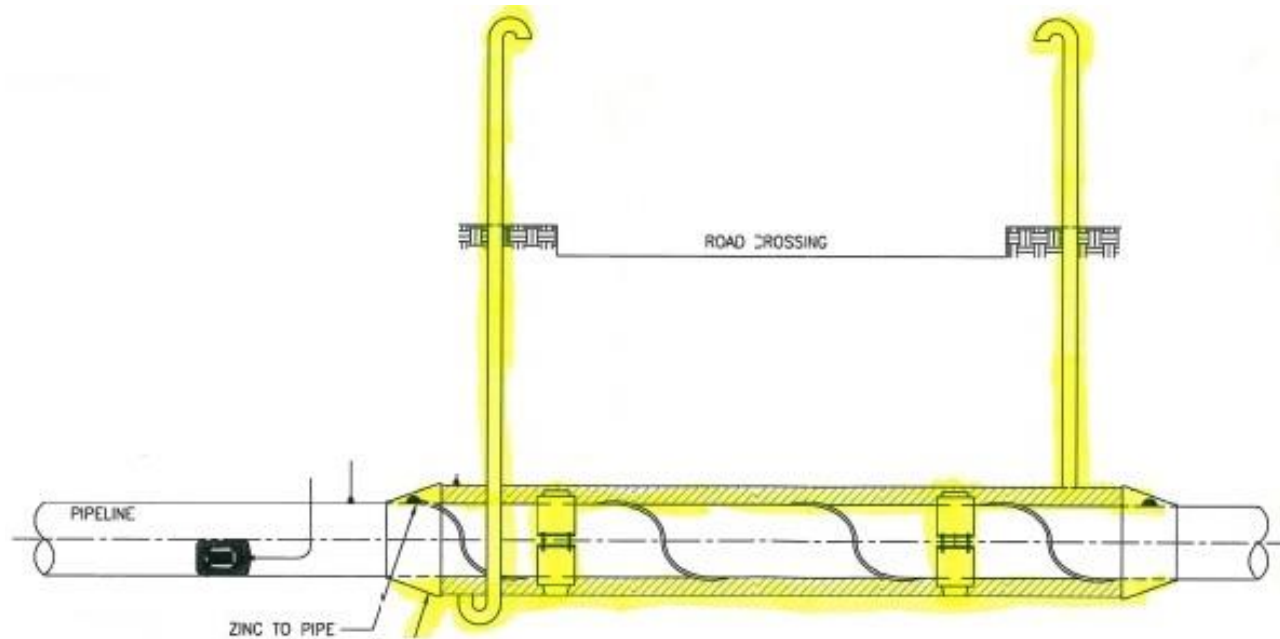
•Casing “Cathodic Protection”
